Street Sign Design and Location Assessment

June 30, 2002

Richmond Regional Planning District Commission

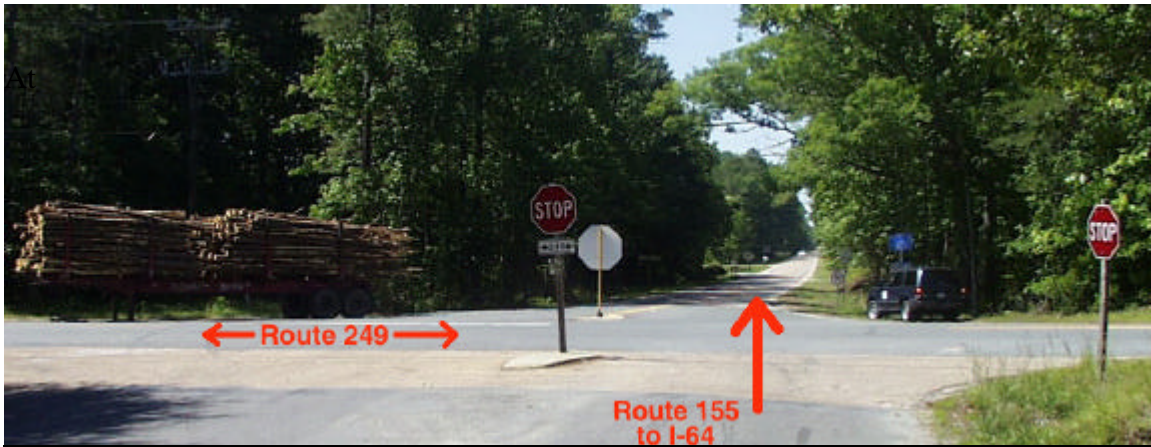
Figure 1. Intersection of Route 155 and Route 249, New Kent County, VA.

At the intersection of Route 155 and Route 249 in New Kent County, the stop sign is located in the center of the roadway on an island. It is obvious, by the condition of the sign post (Figure 2) and the many skid marks on the pavement, that the location of this sign is hazardous. New Kent County Sheriff's Department (NKSD) has observed that the sign's location has contributed to several accidents. An advance traffic control sign (Figure 3) with a "stop ahead" symbol precedes this sign. It is correctly located according to VDOT standards and visible to traffic. However, because of the number of accidents originating from this direction of travel, signage with intersection improvements may be warranted.

Route 249 provides access for traffic to Interstate 64 and handles many large vehicles such as school buses and tractor trailer trucks, including the logging truck seen in Figure 1. Having the sign located in the center of the road can create a hazard for large vehicles navigating their way to Interstate 64. The sharp turn may be difficult for the trucks to maneuver due to the limited turning radius, causing the sign to be removed from its housing.

It appears that the sign at this intersection has both poor visibility and location. To improve visibility it may be necessary to mount a warning beacon on the stop sign at this intersection, making the sign more apparent. Another option would be to place rumble strips to alert the driver of the upcoming event, but neither of these suggestions would reduce the hazard to large vehicles when making a turn. To rectify the large vehicle navigation issue, an option would be to create a channelized intersection and move the sign to an island located on the right side of the centerline providing a wider turning radius for larger trucks (Figure 4).

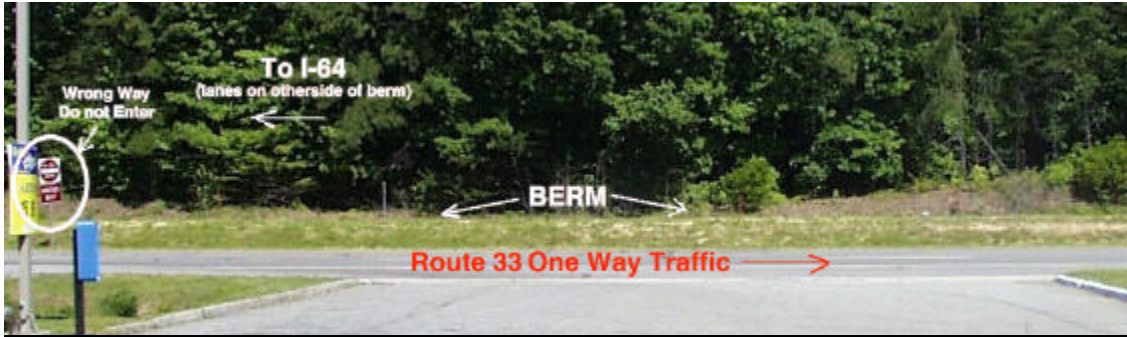
Figure 5. Route 33 north of I-64, New Kent County, VA.

In the past there was a one-way sign located across from the entrance/exit in question, but has since been removed and not replaced. The business owner was unsure if the sign was intentionally or accidentally removed. Presently, only signs stating “wrong way” remain (see Figure 5). The wrong way signs are not apparent until a driver is already traveling into head-on traffic.

It appears that this intersection needs attention due to the number of severe accidents that have occurred. With the amount of out of town motorists traveling through this area, a one-way sign needs to be located across from the entrance/exit of the gas station. An unfamiliar motorist may mistake the northbound lanes as a two-way street due to the inability to see across the berm and enter the lanes traveling in the wrong direction.

A sign instructing a motorist how to return to I-64 by traveling northbound and making a U-turn at the next turn around could be placed in the median. This could be done by placing an appropriate sign so not to interrupt the landscape. A solution that would be the most costly and least desirable would be to cut the berm and increase visibility of the southbound lanes. Allowing the motorist to see that Route 33 is a divided highway could

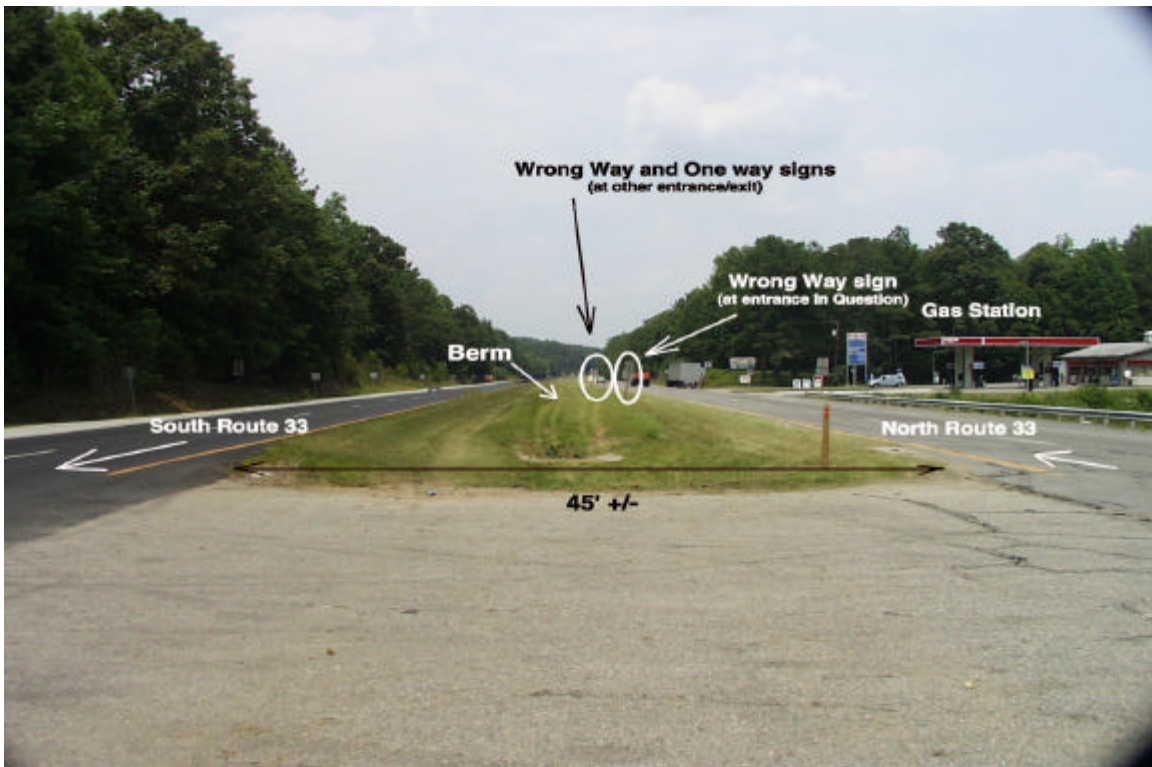
Figure 6. Median across from Exxon station on Route 33, New Kent County, VA

A local gas station owner identified the sign issue at this location. He reported that many drivers are confused about access to nearby I-64 from the gas station. There is a large berm in the median, which is 45 feet +/- (see Figure 6), dividing the north- and southbound lanes of Route 33. A one-way sign is placed opposite the location of one of the two entrances, but is absent from the second entrance (Figure 7). Drivers have become confused and a few people have mistakenly driven south in the northbound lanes. The station owner stated that a head-on collision occurred recently, due to this confusion.

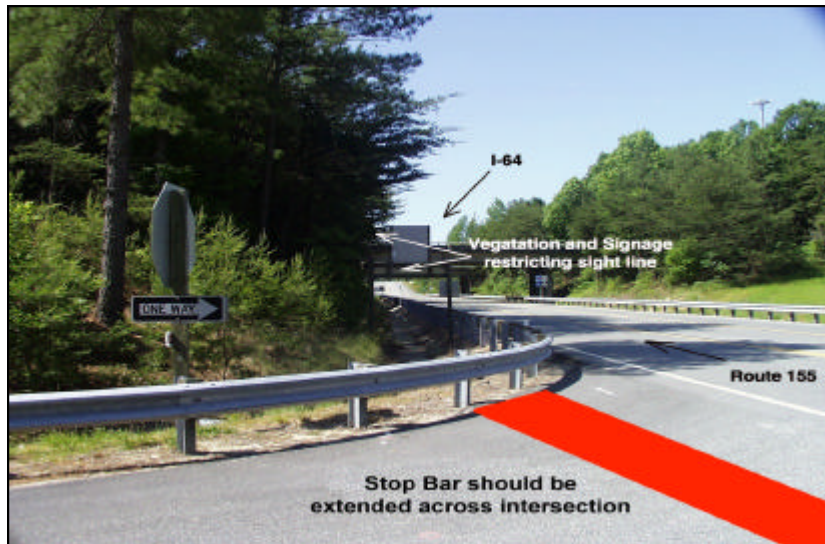
Figure 8. Intersection of westbound I-64 off ramp, exit 214 and Route 155.

NKSD also identified the intersection of Interstate 64 and Route 155 as another intersection with signage problems in New Kent County. The stop sign is located on the left of the intersection and a stop bar only covers a portion of intersection. Many people do not understand that the stop sign pertains to them and they yield instead of stopping. The NKSD recommendation was to place a second stop sign to the right of this intersection and extend the stop bar to cover both lanes (Figure 8).

It appears that this intersection could use a couple of minor improvements to enhance safety. In order to increase sight distance, the vegetation could be cut back or trimmed. A large directional sign should be moved or redesigned (Figure 8). By placing an additional stop sign and extending the stop bar to cover the entire intersection drivers will become more aware of the potential danger. Reduced speeds and signs warning travelers on Route 155 that an intersection is ahead may be warranted to increase safety at this intersection.

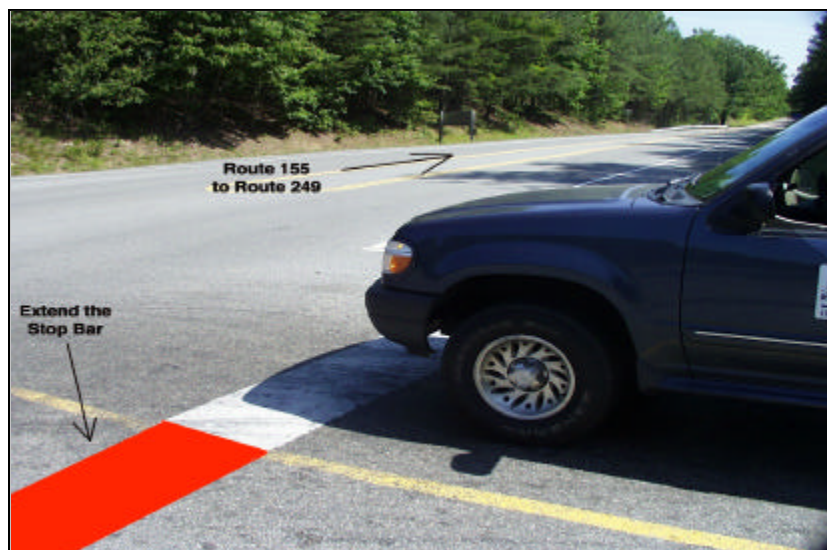
Figure 9. Intersection of westbound I-64 off ramp, exit 214 and Route 155.

This intersection was also identified by the NKSD, due to the lack of sight distance. As demonstrated by the preceding photos, sight distance is reduced by vegetation. Even if the driver pulls completely to the stop bar, sight distance is reduced, causing drivers to “roll” into the intersection. This intersection may need immediate attention because traffic volumes at the intersection are increasing due to the growth on the surrounding areas.

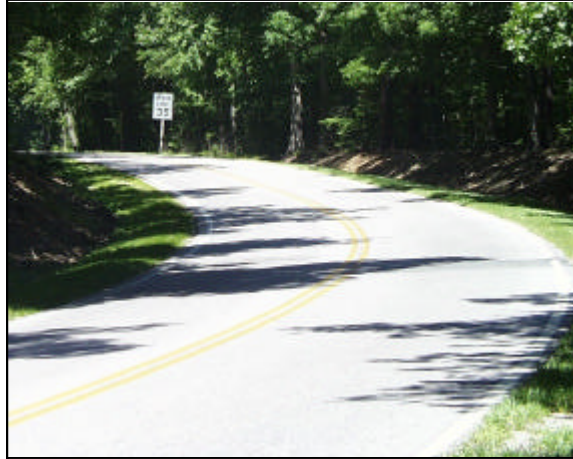
Figure 10. Curve on Route 5.

In Charles City County on Route 5, approximately 1.5 miles east of Route 639, the speed limit is reduced to 35 MPH.

recommended that VDOT investigate this segment of the road and evaluate proper speed limits to rectify this situation.

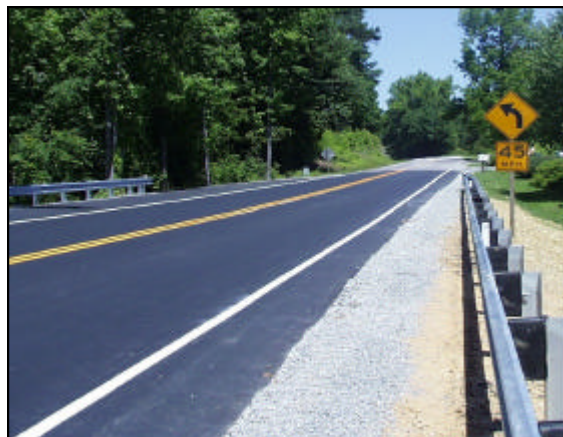
Figure 11. Maximum safe speed in curve sign, Route 5.

Approximately 0.4 of a mile further down Route 5 is a sign stating the maximum safe speed in the curve is 45 MPH. It is unclear why a posted maximum speed of 35 MPH, on a straight stretch of road earlier, is allowed to increase to 45 MPH on a curve. It is

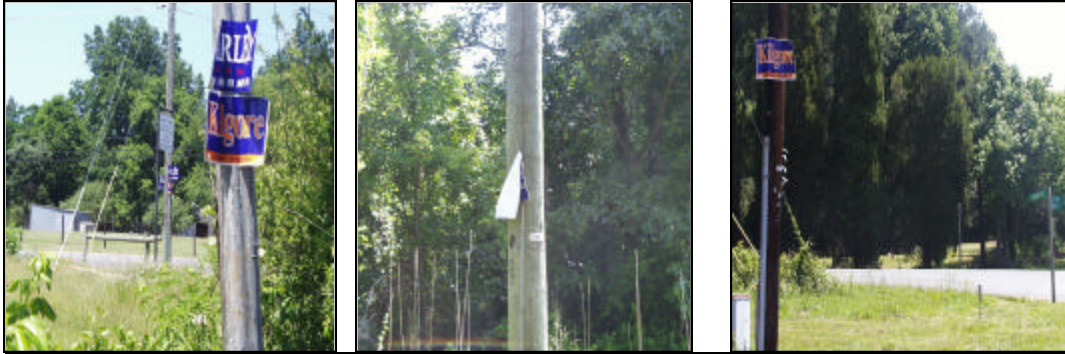
Figure 12. Three examples of outdated political signage.

The Charles City County Development Department identified political signs as a significant signage problem in the locality. Although political campaign signs are not street signs per se, they have become de facto street signs because they are intended to be read by motorists. These signs are left up until VDOT or the county removes them, but neither the county nor VDOT have the resources to do so. The signs are often times illegally placed on utility poles and street signs. If not removed, eventually the signs will deteriorate, falling to the ground, becoming litter.

To resolve this problem in the future, the county may develop a litter prevention program and request that the citizens assist with removal. The county could also involve the local utility companies by having them remove the signs if an employee is in the vicinity. As a last alternative, the county could impose fines on the campaign committee or even the campaigner. This could possibly result in the campaigners being more aware of their sign removal efforts.

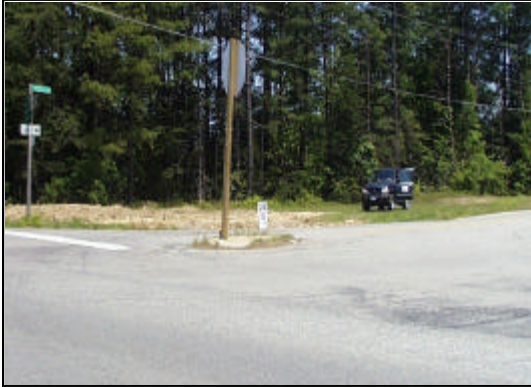
Figure 13. Intersection of Route 605 and Route 622.

Having signs mounted on sign islands appears to be common in the rural communities. In at least two instances in Powhatan County, there is a stop sign placed in the center of the road which has become a hazard for motorists (this is similar to the issue in New Kent County at the intersection of Routes 155 and 249). In particular two intersections are identified in Powhatan County. Figures 13 and 14 are at the intersection of Route 605 and Route 622 and Figures 15 and 16 are at the intersection of Route 615 and Route 628. The signs at the aforementioned intersections have been involved in many incidents and are not very secure.

VDOT Chesterfield Residency stated that VDOT was working to eliminate the sign islands and relocate the signs to the roadside. It is recommended that the signs be repaired to ensure safety, but ultimately relocation would be the best possible alternative for these signs.

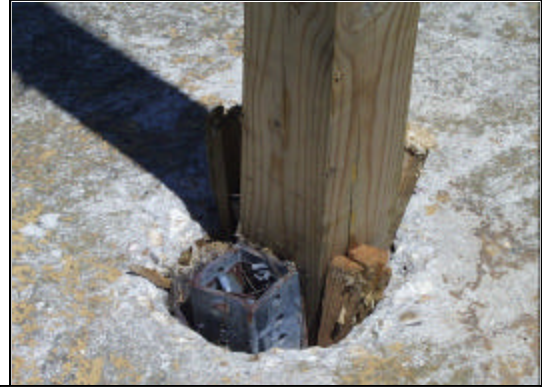
Figure 14. Sign post at the intersection of Route 605 and Route 622.

The Route 605/622 intersection sign has been removed and replaced several times. The sign currently has numerous wedges between the post and concrete island to keep it in place. Figure 14 shows the base of the post and the wedges. Staff noted that the pole was not secure and could be dislodged easily.

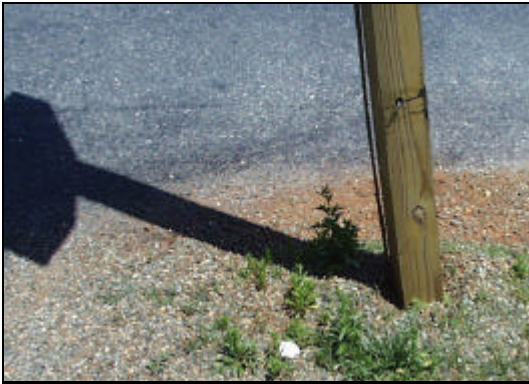
Figure 15. Sign post at the intersection of Route 615 and Route 628.

There are several observed factors that affect the driver's ability to properly negotiate the intersection of Route 615 and Route 628:

A possible solution for this intersection may be to move the stop sign to the side of the road and to place a stop ahead warning sign and/or rumble strips at an appropriate distance from the stop sign. This solution would also assist the motorist regarding the lack of site distance. Moving the sign to the side the intersection will open the intersection and possibly prevent incidents involving the sign and vehicles.

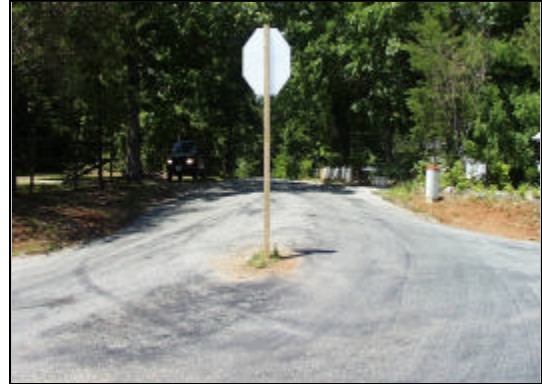
Figure 16. Intersection of Route 615 and Route 628.

As mentioned before, having a sign located in the middle of the intersection causes a potentially hazardous situation and reduces the functionality of the intersection. In today's society it appears that "bigger is better" when it comes to vehicles. Having an increased number of larger vehicles may require VDOT to evaluate some of the intersections that were designed for small passenger vehicles.

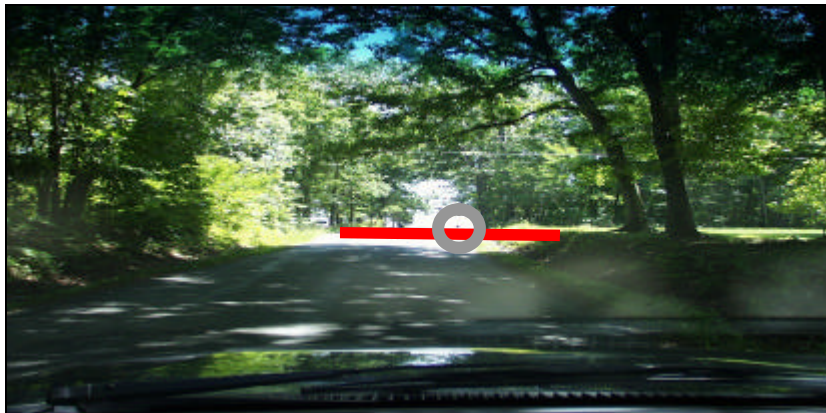
- 1.) The stop sign is located on the back side of an incline making the sight distance to the sign very short. (Figure 17)
- 2.) The short turning radius is difficult for SUVs and large construction vehicles to navigate
- 3.) Poor lighting.

Figure 17. Sitting in SUV facing north on Route 615. The stop sign is circled in gray and the red line represents the apex of the roadway.

The tree canopy blocks sunlight from the road causing the sign to be more difficult to see from a distance (Figure 17). A fast approaching vehicle may not see the sign until it is too late, causing property damage. An advance warning mechanism such as a stop ahead warning sign or rumble strips may assist in diverting a potentially hazardous situation.
